**Landscape Management Plan For PIN Kebeles in Sankura Woreda**

**Kebeles: Worabe Sinbita, Menzo, Menzo Feten, Feten, Weteta,  
Bercho, and Bercho Kulfo Kebeles of Sankura Woreda**

**Biophysical and Socio-economic Analysis of the Seven Kebeles for  
LMP Development**

**Under the Project “Ecological Stability of Dijo and Bilate watershed  
of Sankura and Halaba Special Woredas”**

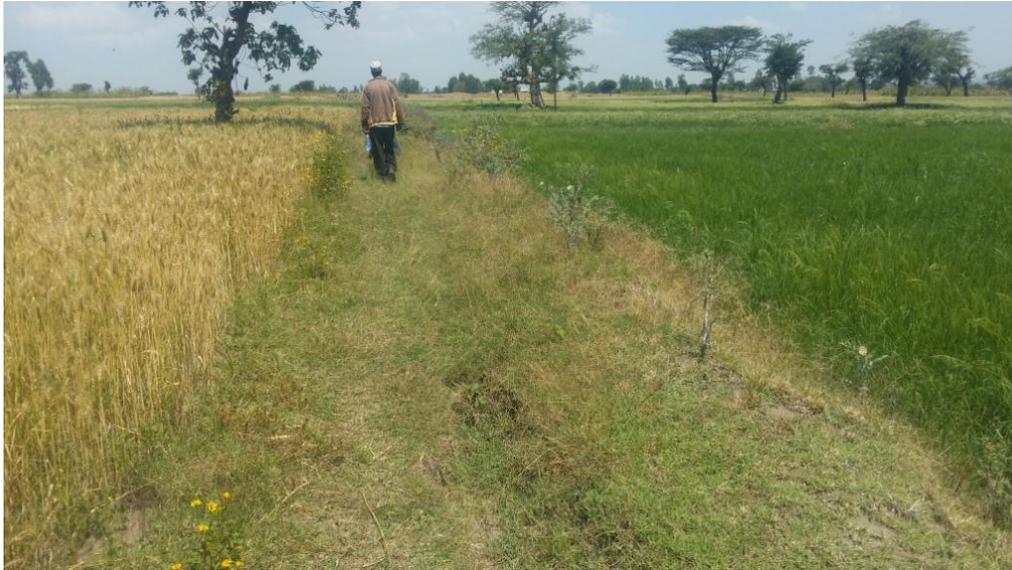
Figure 2. Well managed terrace in Menzo Kebele, Sankura Wereda

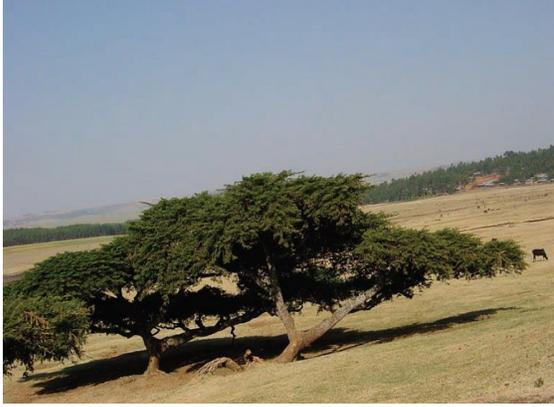
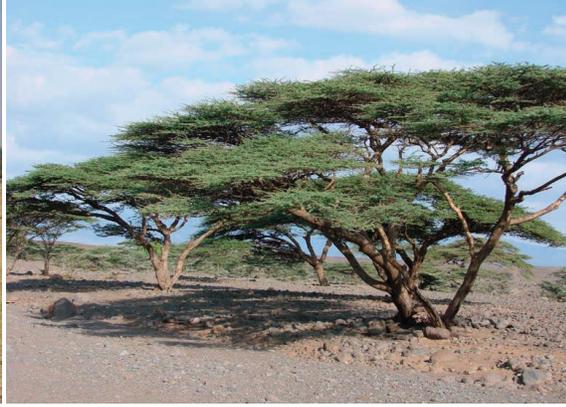
Figure 7. Tree species adaptable to Worabe Sinbita Kebele

*Acacia abyssinica*

*Acacia tortolis*

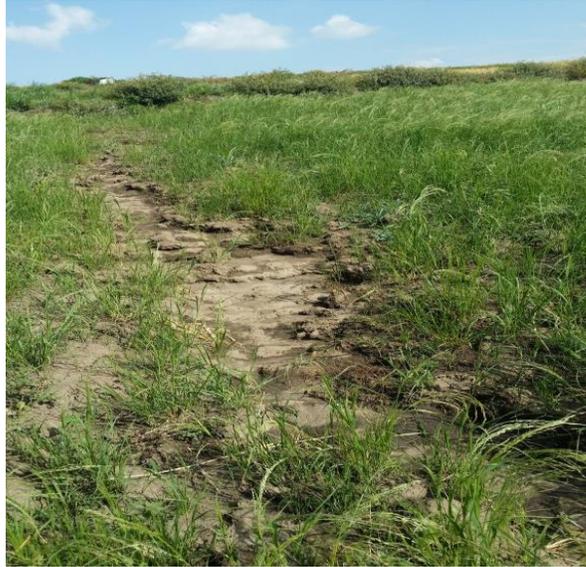
Figure 92. Traditional plough made drainage lines progressively developing to gully (*Sankura Woreda, Bercho Kulfo Kebele*)

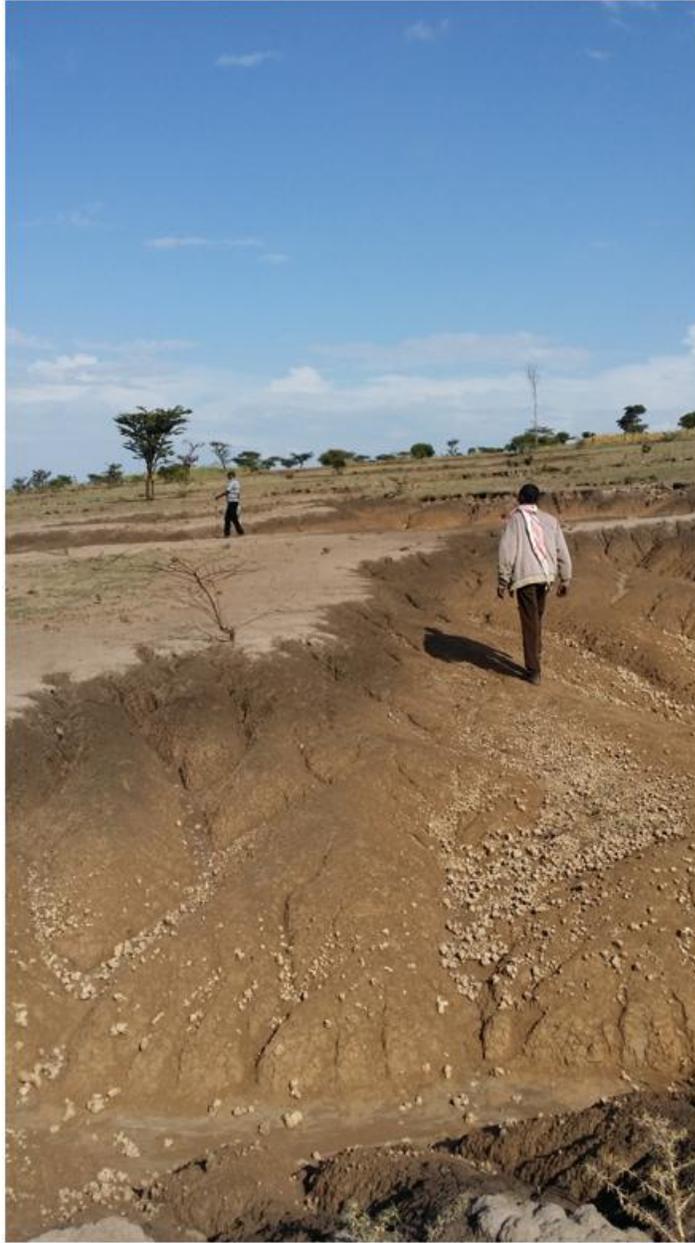
Figure 93. Poorly managed area closed land at the border between Weteta and Qulubi Kebele where most gullies were populated

In denuded watershed like, Qulubi, Weteta, the northern part of Bercho Kulufo, *Kulufo and Werabe Sinbita kebele* with its accelerated runoff, re-establishment of the vegetative cover would be the appropriate measure to take.

The area must be planted with shrubs and trees to improve the soil condition, increase infiltration and reduce surface runoff. In serious cases, the absorbing capacity of the catchment can be increased by “contour bunding”.

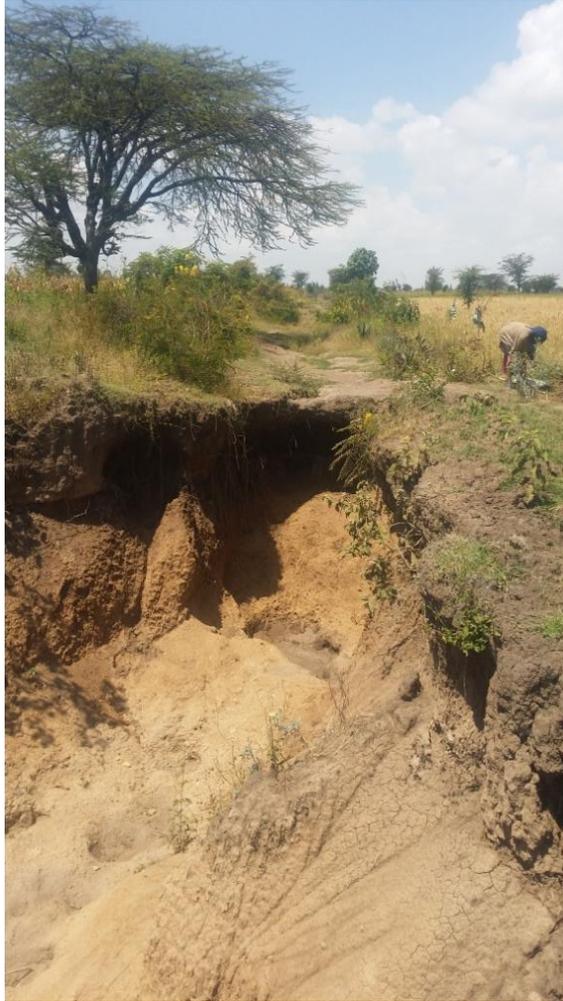
Figure 94. Progressive gully head following cattle trails in agricultural land of Weteta kebele of Sankura Woreda

If the gully does not belong to the natural drainage system and stabilisation is attempted by planting only, the runoff entering the gully head has to be intercepted by a diversion canal.

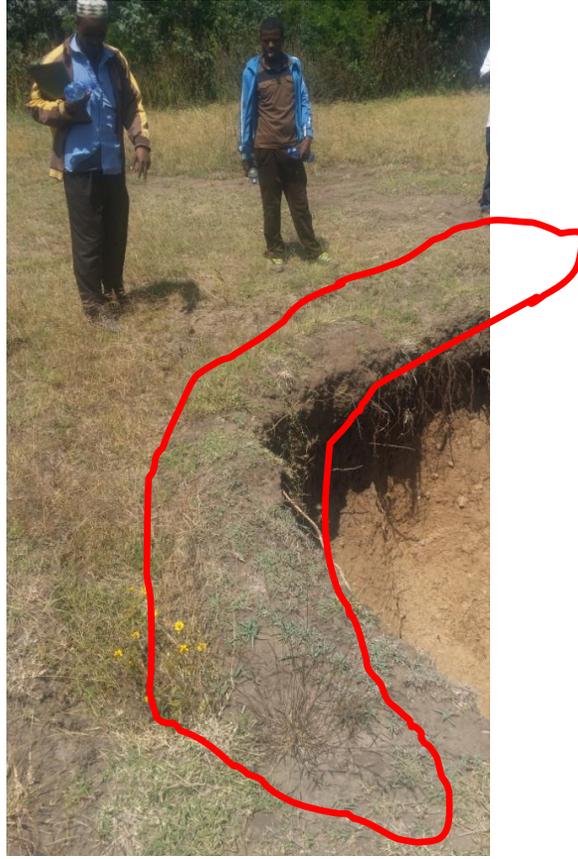
Figure 95. Canal dug above the gully head to stop its progressive development in Weteta kebele of Sankura Woreda

This canal is dug above the gully head at a distance of once or twice the depth of the gully. It should have a trapezoidal cross section and must be designed wide enough to conduct maximum rainfall. Precautions must be taken that not a new gully develops from the diversion canal, which should be checked after every rainfall event.

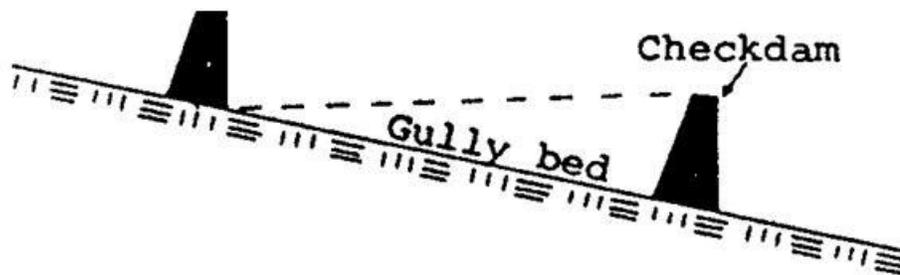
Figure 99. Spacing of checkdams (Source: Manual of Reforestation and Erosion Control, Agpaoa et al., 1975)

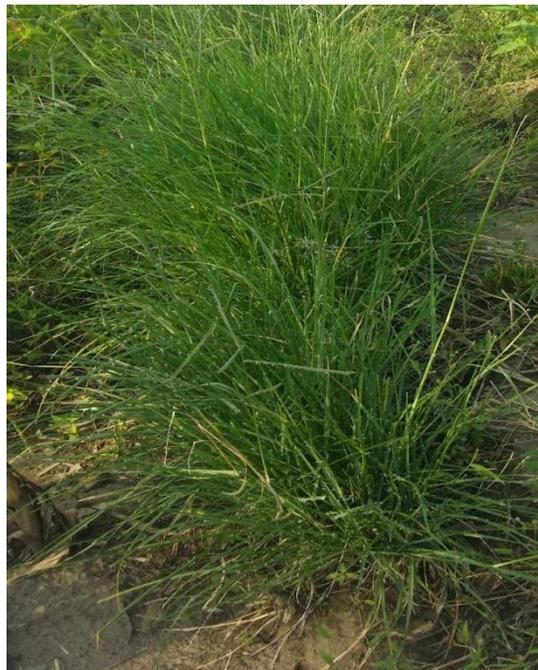
Figure 103. Dual purpose creeper grass locally called “*Engecha*” in Halaba Woreda potentially useful for plantation on checkdams

When large quantities of run-off are expected, it is advisable to use some concrete for the notch and the crown of the dam, or to cover everything with a wire netting in the case of Stone checkdams. Below the dam an apron has to be constructed with stones. On the upstream side the dam has to get an earth fill for greater strength. Finally, the structure is supplemented by planting seedlings and cuttings of suitable species with a dense and wide spread root system like elephant grass, vetivar grass, or dual purpose creepers like "*Engecha*" (Figure 12) along the banks.

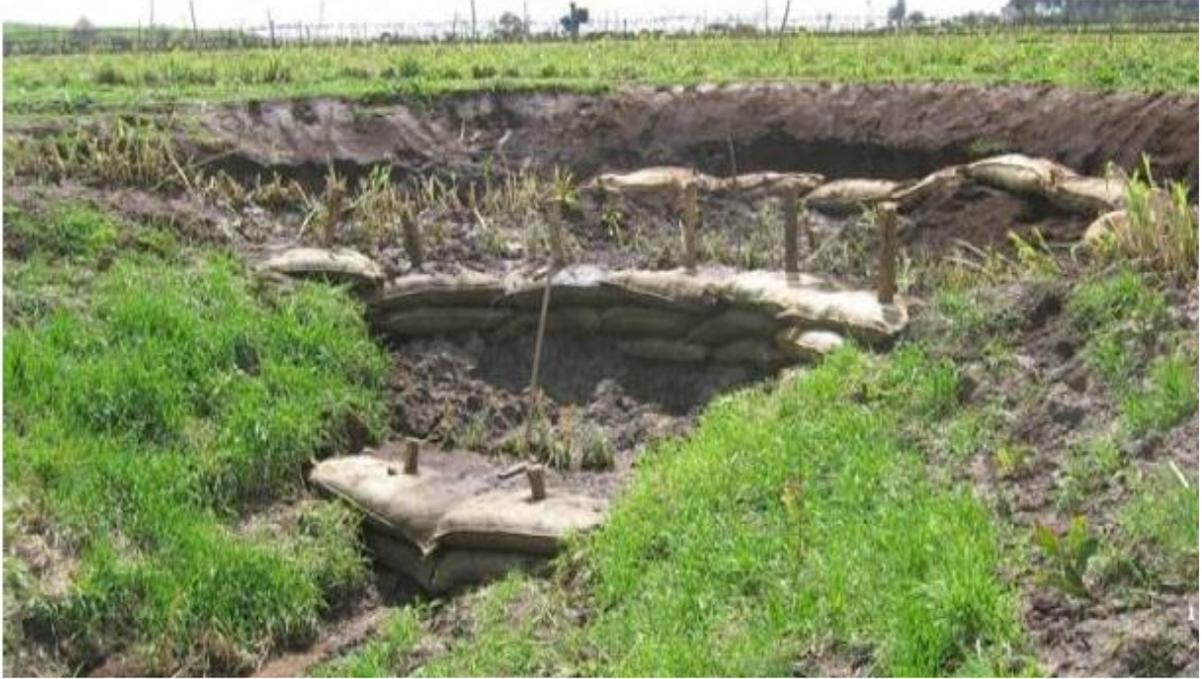
Figure 106. Sand/soil bag checkdams for gully stabilization in Amhara Region
